DEPARTMENT OF NATURAL RESOURCES
DIVISION OF OIL, GAS AND MINING

RE: Site Inspections; UMETCO Minerals Corporation; Calliham (M/037/023), Wilson-Silver Bell (M/037/027), and Deremo-Peterson (M/037/025) Projects, San Juan County, Utah

Date of Inspection: May 1, 2002
Time of Inspection: 8:30 to about 11:30 a.m.
Conditions: Mostly clear, 40's, windy
Participants: Frank Barnett and Tony Bates, UMETCO; Doug Jensen, and Paul Baker, DOGM

Photographs

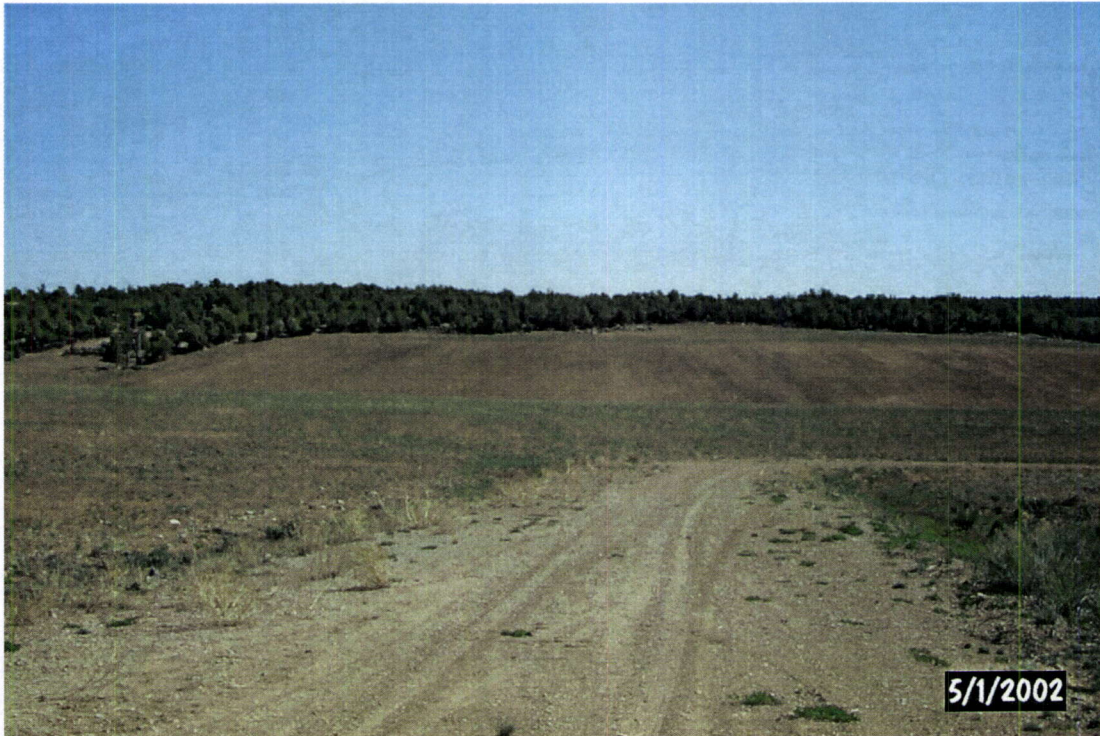
Photos 1 through 3 show the mine site. It has been graded to fairly gentle slopes that match surrounding topography quite well. The area was seeded in the fall of 2000, and the vegetation is progressing well. From a distance, it looks like there is little vegetation on the slope shown in Photo 1, but this slope actually has good vegetation cover considering there has only been one full growing season since the site was seeded. In my opinion, the vegetation on this site will continue to grow, and the operator should have little trouble meeting bond release criteria. There are some rills on one of the slopes, but they are relatively minor and should heal once vegetation is better established.

Photo 1. Calliham Mine looking toward the waste pile. There are a few rills on this pile.

I am fairly confident there will be adequate vegetation at the Calliham Mine, but we should still check it whenever possible.

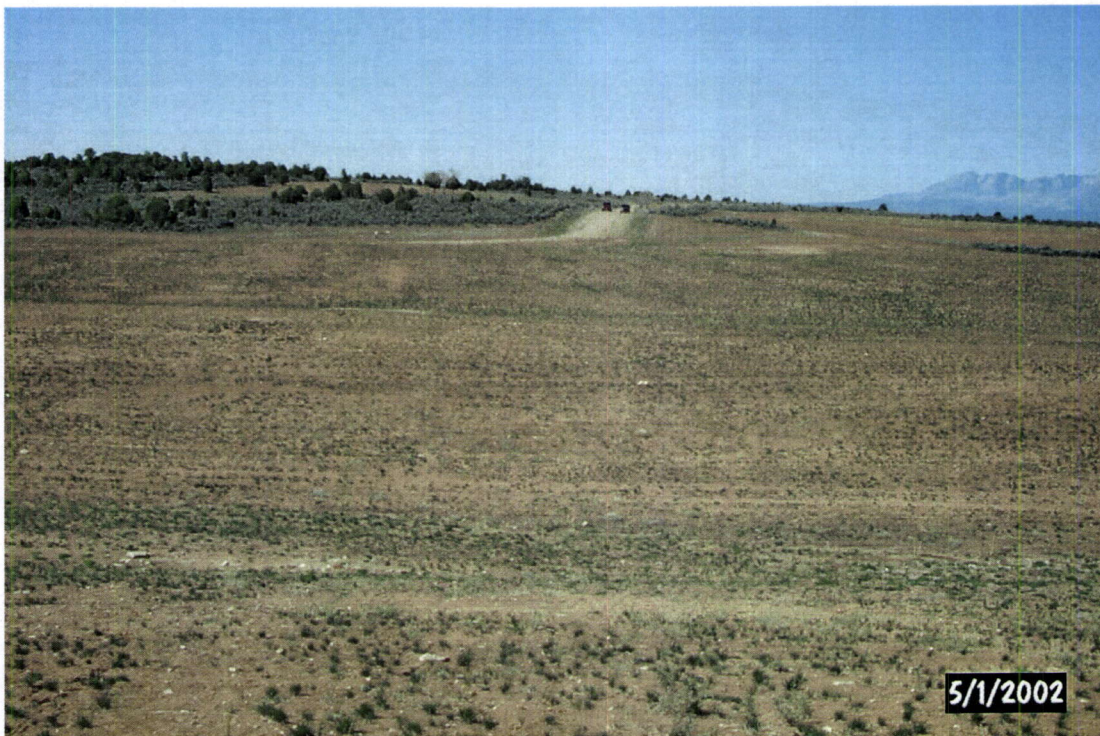
Photo 2. Calliham Mine looking from the waste pile (opposite direction as Photo 1).

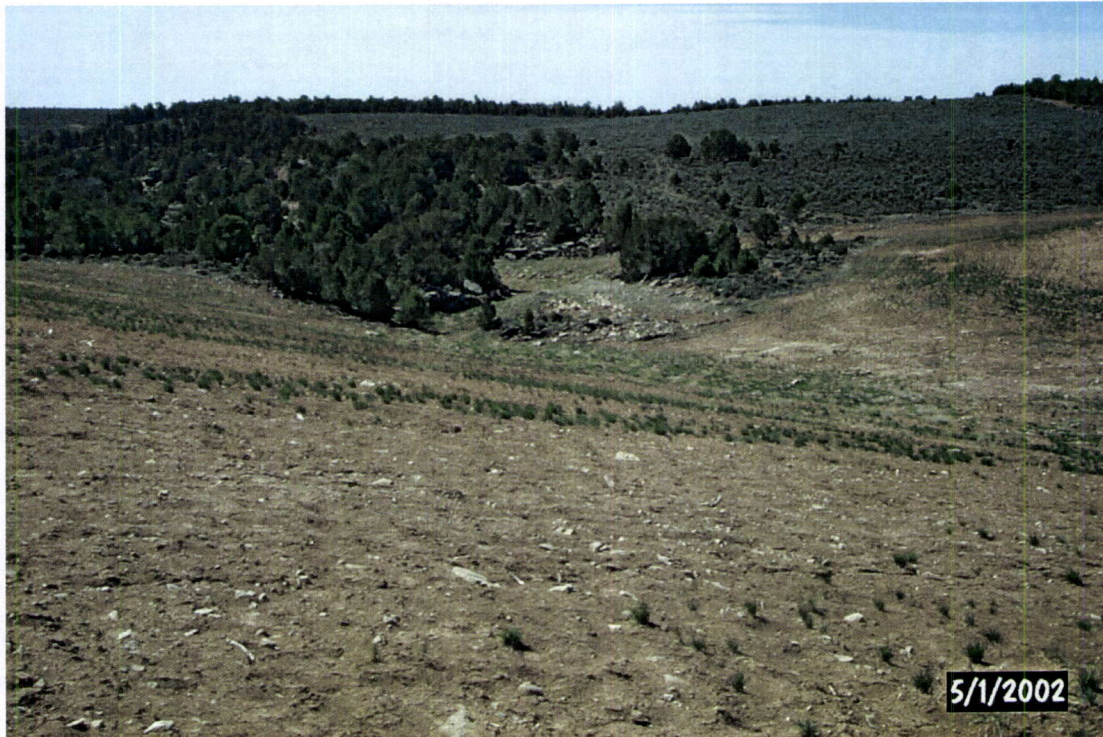
Photo 3. Calliham Mine looking toward the top of Wildhorse Canyon.

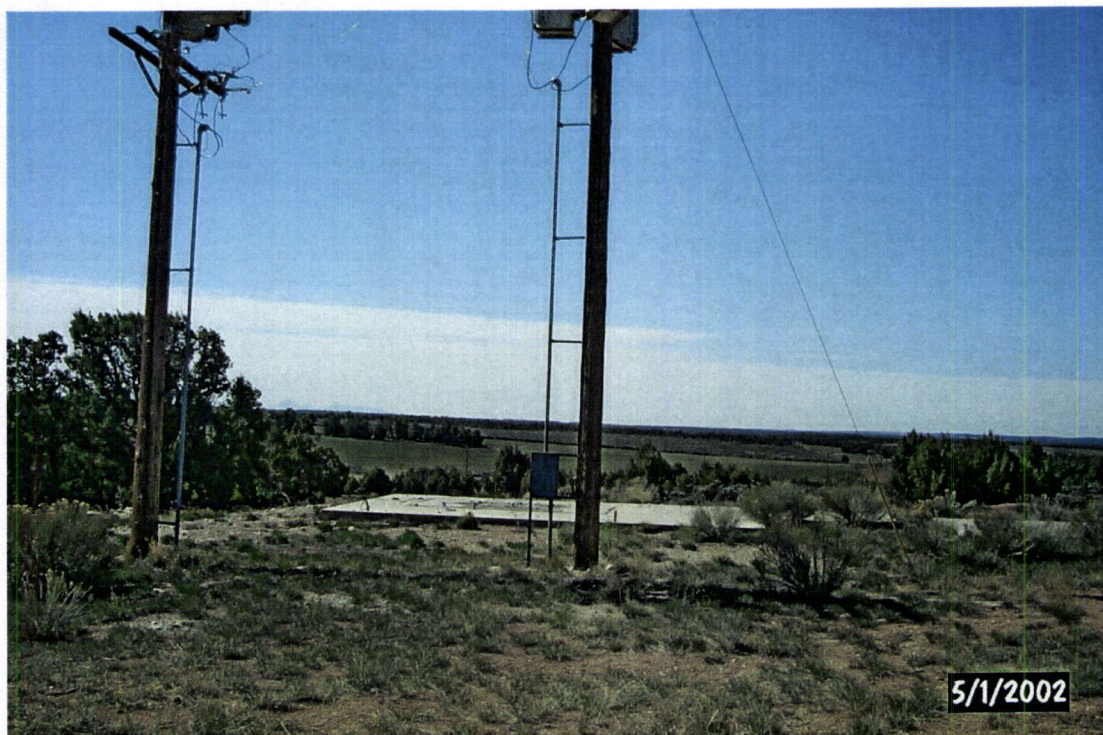
Some of the buildings and other structures, including power poles, erected for the mine have been left at the land owner's request. The power poles have Pacificorp labels, but according to Mr. Bates and Mr. Barnett, Utah Power and Light does not claim them and is not willing to replace them. Several of the poles leading into the mines have broken, and because they are not functional for the postmining land use, they need to be removed. There are some other poles with transformers near some of the vent shafts, and these appear to still be usable. The land owner has also requested that these be left. One of these vent shafts is shown in Photo 4.

Photo 4. Vent shaft near the Silver Bell Mine. The concrete pad is a compressor platform.

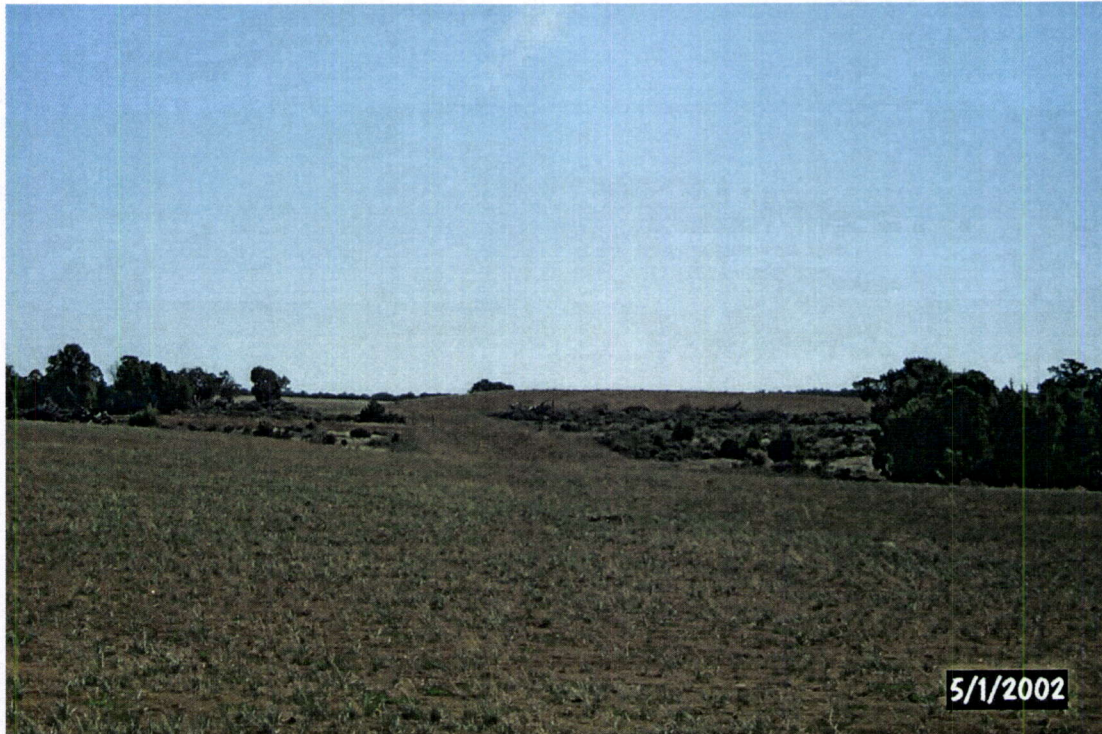
Vegetation on the waste disposal area at the Silver Bell Mine appears to be doing very well. I am a little more concerned about vegetation at the Wilson Mine. Although it is more sparse and consists of more sweet clover than I would like to see, I believe it will probably progress and that reseedling will not be necessary. Photos 5 and 6 show the Silver Bell Mine waste disposal area.

Photo 5. Silver Bell Mine waste disposal area with Wilson Mine in the background.

At the Wilson-Silver Bell Mines, the operator needs to remove the power poles leading to the mines. We will want to monitor vegetation, especially on the waste disposal area at the Wilson Mine, although I believe the vegetation will ultimately succeed.

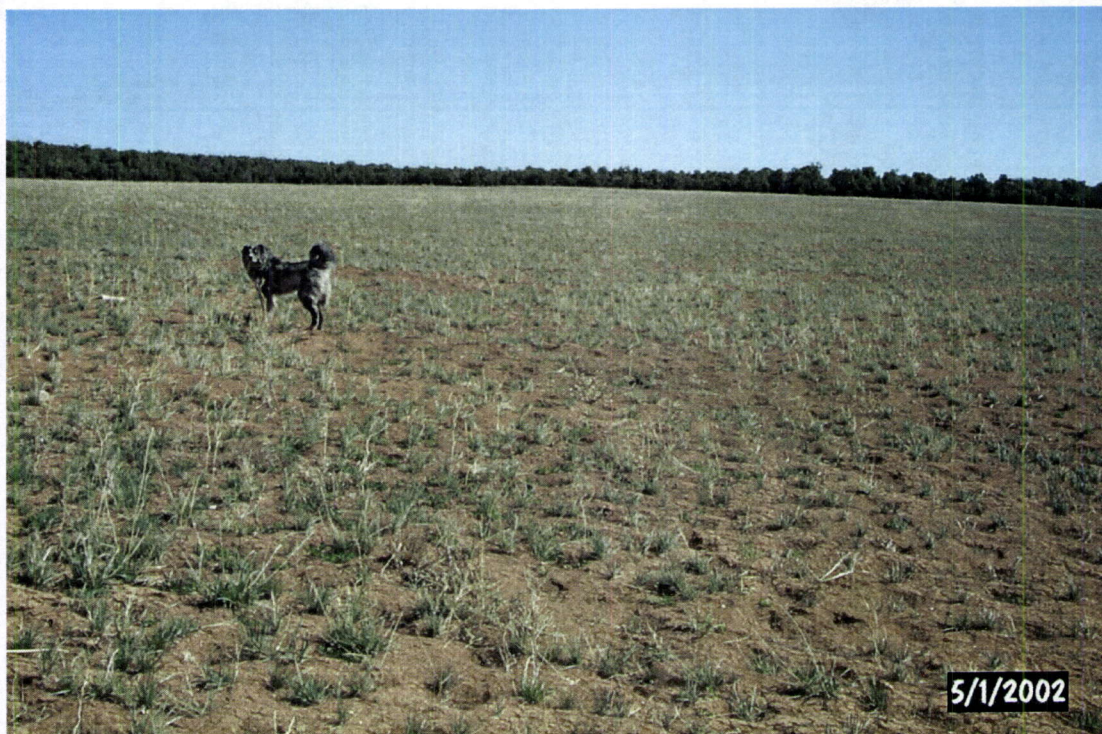
In Photo 6, one can see the small depressions that were made when the site was seeded. This was done with the idea that the depressions would increase water retention and vegetation establishment and growth. We could not tell that there was greater establishment in the depressions compared to outside the depressions; however, I suspect that they increase the amount of moisture held on the slopes and improve growth. Larger depressions, such as those the operator used at the Sunset Mine, may be more beneficial.

Photo 6. Silver Bell Mine. Note the small depressions in the soil.

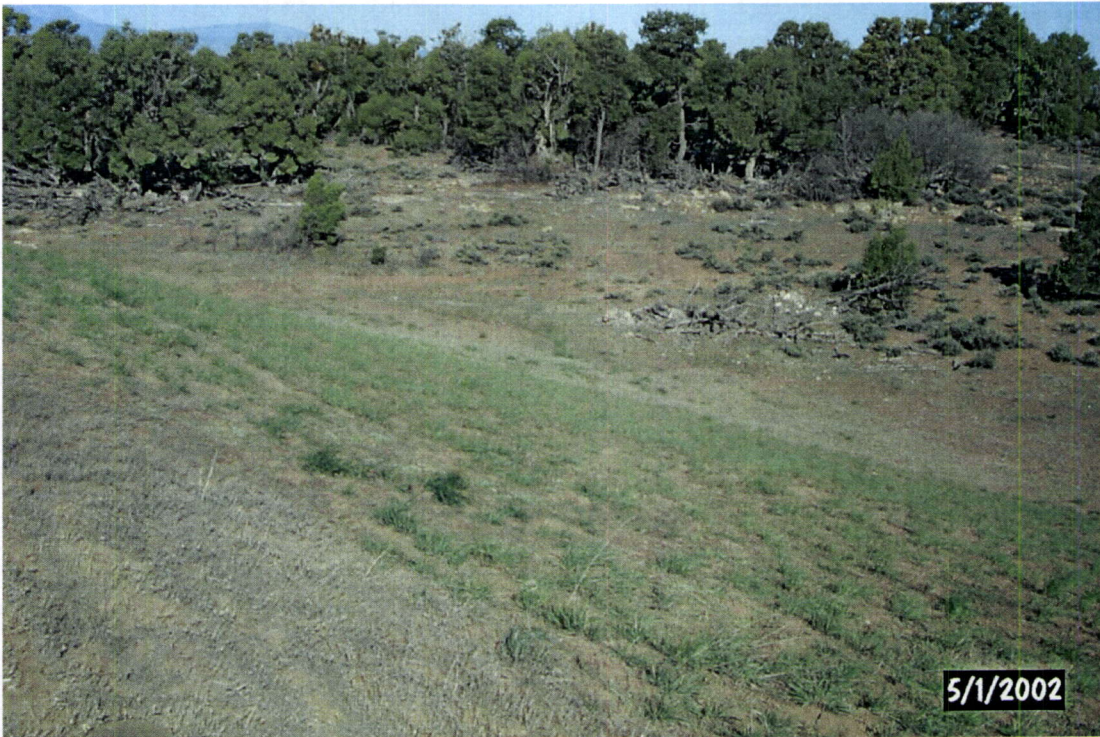
The Deremo-Peterson Mine was seeded with grasses at the land owner's request. Seeding was done in 1999. The north side of the waste pile is well vegetated, but other portions of the pile have scattered vegetated areas (Photos 7, 8, and 9). There was an ore pad north of the waste disposal

Photo 7. Deremo-Peterson Mine, north side of waste disposal area. Note the amount of perennial vegetation compared to photos below.

Vegetation establishment and growth at the Deremo-Peterson site has almost certainly been adversely affected by lack of rainfall, but considering how well the two nearby sites have done, this cannot be the only reason for the lack of vegetation in this area. The site does not meet the revegetation criteria for release.

I suggest that the operator wait until fall then reseed those areas where there is minimal perennial vegetation. Because of the number of weeds that have become established, I have some concerns about reseeding, but I believe there is not enough perennial vegetation for it to spread and meet bond release criteria without supplemental seeding.

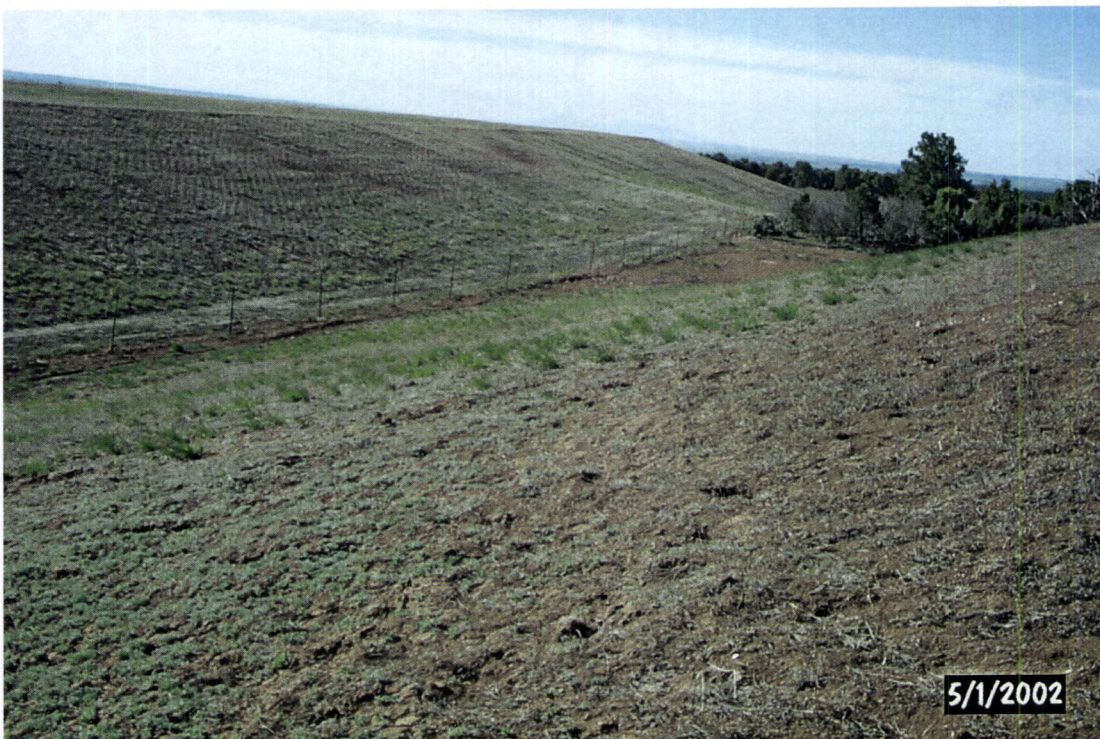
Photo 8. East side of Deremo Peterson waste disposal area. Note the relatively small amount of perennial grass cover compared to the north side of this pile. The fence is at the Colorado state line, so the pile in the background is in Colorado.

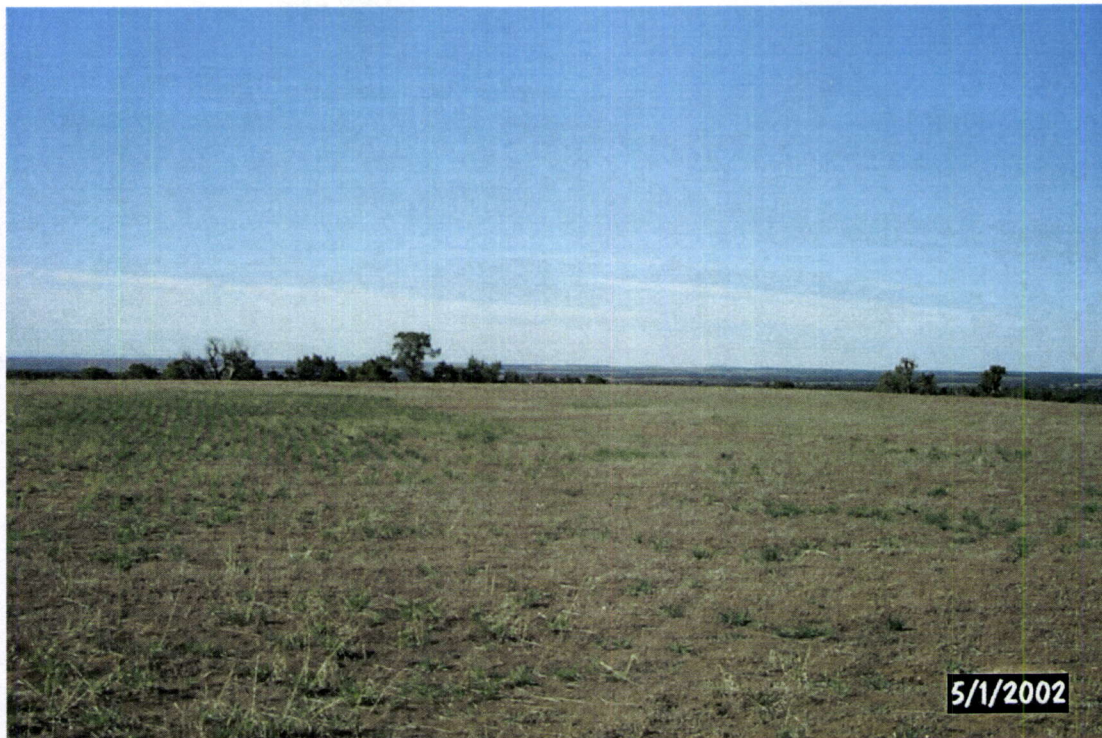
Photo 9. Top of the Deremo-Peterson waste pile.

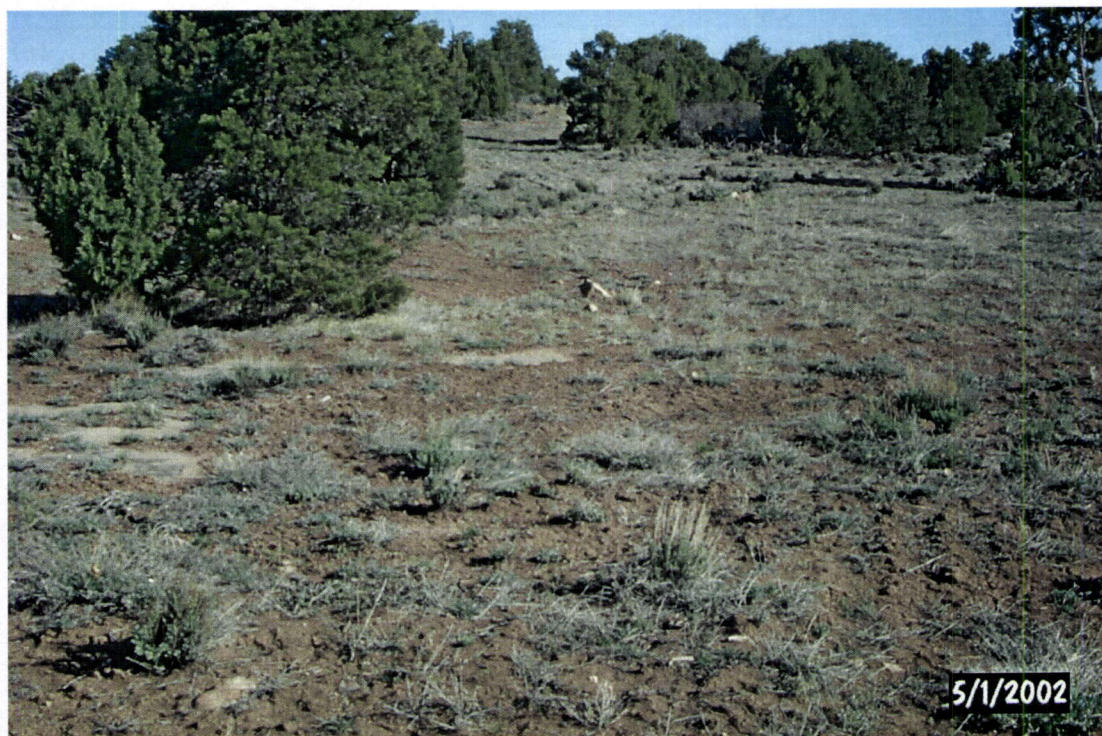
area, and it has little or no desirable vegetation. We were told that this area was essentially bedrock with just a couple of inches of soil placed on it. I also took a photo of a nearby undisturbed area for comparison (Photo 10). The undisturbed area also had little soil, but it may be unfair to compare a near-climax community to a site reclaimed three years ago.

Photo 10. Undisturbed area near Deremo-Peterson Mine.
